# Performance of Sound Insulation in Buildings — A Case Study

Marcus Vinícius Manfrin de Oliveira Filho and Paulo Henrique Trombetta Zannin

Federal University of Paraná, Brazil

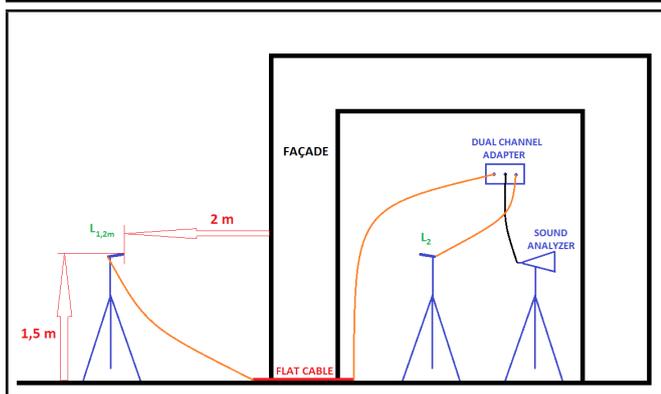
Figure 1. The measurement scheme.

The parameters  $L_{1,2m}$  and  $L_2$  were measured simultaneously by using two microphones, a dual channel adapter, and a flat cable. This flat cable could be passed through an element that separates the facade (door or window) even when it was closed. This was necessary because if a cylindrical cable was used, a crack would have had to be left open in the separating element, which would have impaired the accuracy of the measurement of the sound insulation, thus underestimating its levels.<sup>14</sup> All data was collected in the afternoon over the course of several days and, although the equipment set up time was long, each measurement lasted for only a few seconds.

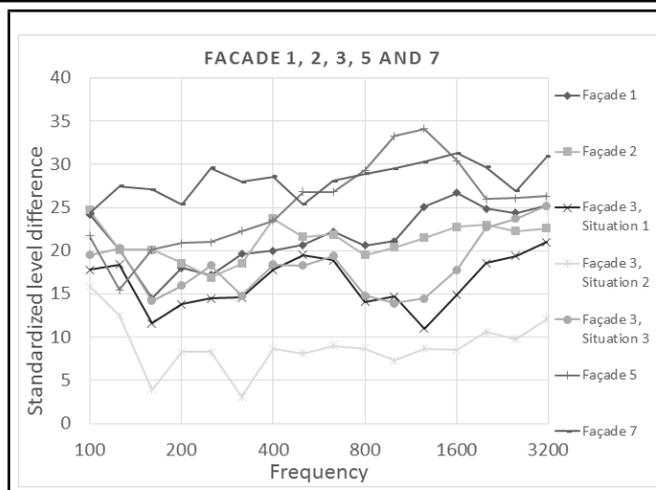
Figure 3. Standardized level difference for facades 1, 2, 3, 5 and 7.

Table 1 shows the room types, location, and building aspects of the eight studied facades. Figures 3 and 4 show the measured standardized level difference curve for all the situations presented in this study. Other measurement relevant descriptions — measured values, photographs, and pertinent comments — are given in the following sections. The global loudspeaker method was used in Facades 1 to 7. Measurements on Façade 8 were taken considering the road traffic noise (other noise sources were negligible in the area) by using the global traffic noise method.<sup>14</sup>

Because the facade area was made of single-layered plain glasses, the levels of sound insulation were decreased in the 500 to 1500 Hz frequency range approximately, when compared to the shifted reference values curve utilized to calculate the weighted standardized level difference.<sup>15,19</sup> In addition, the sliding window did not have an appropriate sealing, leaving gaps between the metal structures that sustained the glasses. These constructive imperfections were caused due to the lack of the window maintenance and to the use of non-standard materials.

Facade 2 presented a poor sound insulation performance in the higher frequencies when compared to the shifted reference curve. The same behavior was found in Facades 4, 6, and 8, in which openings of 0.5 cm were intentionally left, as shown in section 3.4. This suggests that gaps of this magnitude affect the facade sound insulation levels, especially in this frequency range. The cracks found in Facade 2 were consequences of the use of non-standardized materials, which had unfavorable acoustic properties.

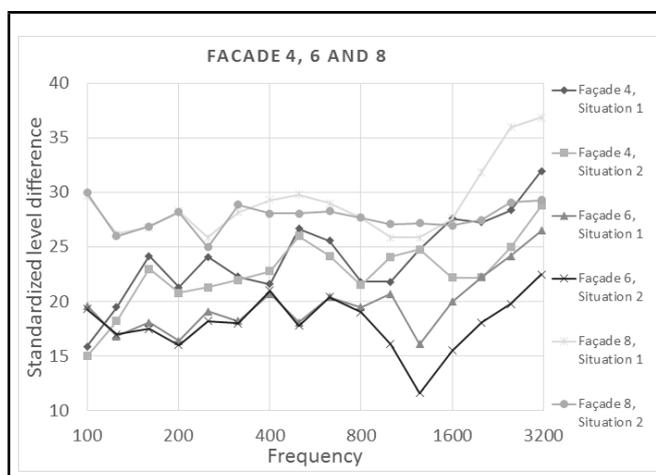
Figure 4. Standardized level difference for facades 4, 6 and 8.

In addition, it was noted that the gaps affected the standardized level difference curve in a similar way for Facades 4, 6, and 8. Sound insulation level curves suffered a significant decrease in high frequencies. Facade 4, for example, had a decrease of 5.4 dB in the 1600 Hz frequency band when compared to Situations 1 and 2; Facade 6 had a 4.6 dB decrease in the 1000 Hz frequency band; and Facade 8 had a 6.9 dB decrease in the 2500 Hz frequency band. The levels in frequencies lower than 1000 Hz remained close in both Situations 1 and 2, as shown in Fig. 4.

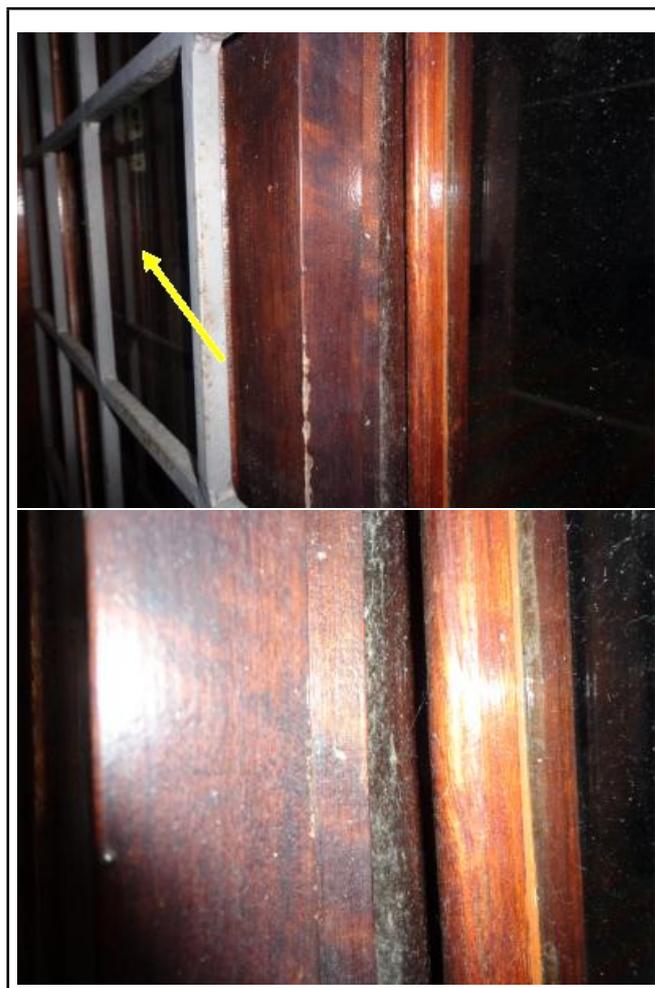
**Figure 5.** Gaps in the window frames of facade 2.

The sliding windows of Facade 2 showed gaps between the wooden window frames and the glass panes, as illustrated in Fig. 5. This type of crack was quite common and often found in Brazilian buildings. A value of 22 dB for the weighted standardized level difference was determined from this measurement, thus indicating that Facade 2 does not meet the minimum 25 dB requirement stipulated by the Brazilian standard for this case.

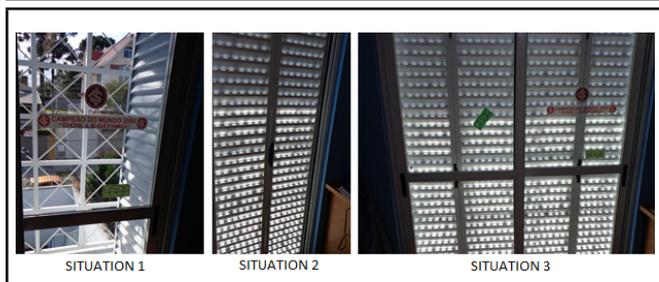
Figure 6. Facade 3 in the three different situations.

1. Situation 1 — Only the glass door closed (metal shutters open);
2. Situation 2 — Only the metal shutters closed (glass door open);
3. Situation 2 — Metal shutters and glass door both closed.

Fig. 6 illustrates the evaluated situations.

As can be seen, Facade 3 does not meet the minimum 25 dB requirement set by the Brazilian standard in any of the three measured situations. The contribution of the metal shutters to the sound insulation combined with that of the glass door is 2 dB for the weighted standardized level difference (from 17 to 19 dB).

Since there are no gaps in Facade 3, the results under the minimum value established by the Brazilian Standard are due to the use of materials with unfavorable acoustic properties, such as light metals and a single layered plain glass door. Similarly to Facade 1, Facade 3 presents low sound insulation levels in the 500 to 1500 Hz frequency range approximately, when compared to those found in the shifted reference values curve described in ISO 717.<sup>15</sup> These weak points were caused by the use of single-layered plain glasses that have had a worse performance than the 10 cm thick masonry walls.<sup>19</sup>

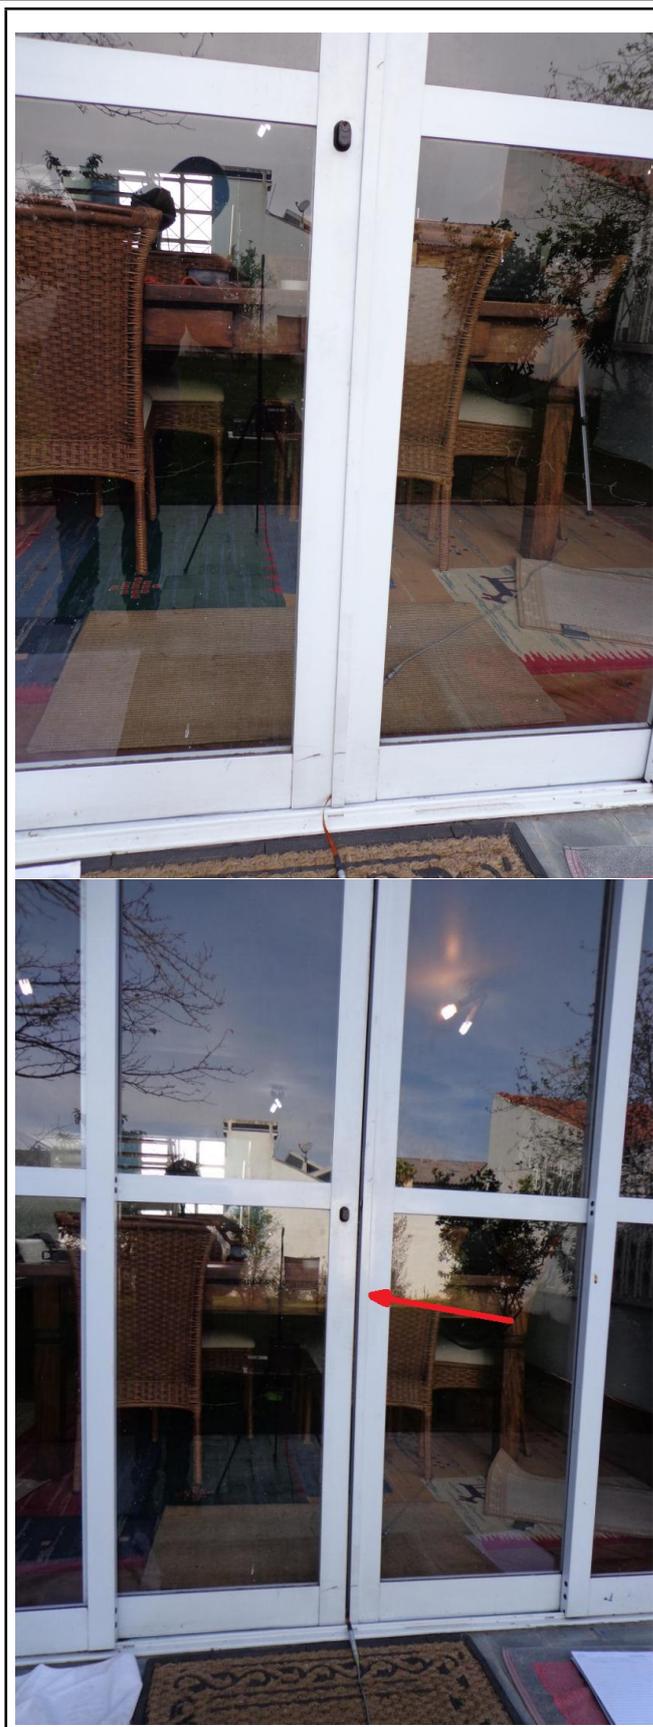
Figure 7. Facade 4 sliding glass door closed, and with an 0.5 cm opening situations 1 and 2.

1. Situation 1 — Glass door / window completely closed;
2. Situation 2 — Glass door / window open 0.5 cm; the opening was left intentionally to simulate gaps in the order of magnitude commonly found in Brazilian buildings.

Figure 7 illustrates Situations 1 and 2.

Facade 4 sound insulation levels are below the 28 dB minimum value recommended by Portuguese standards. The Brazilian standard does not provide for sound insulation levels for rooms other than bedrooms. There were difficulties on

opening and closing the door of this facade due to the friction between the lower part of the door and the metal sliding guide. This constructive imperfection, which could also cre-

ate gaps, was explained by the low-quality workmanship and a lack of maintenance. Additionally, the constructive material, which was a single layered plain glass sliding door, did not offer a high performance sound insulation, which explained the results under the minimum established by the Portuguese standard.<sup>19</sup>

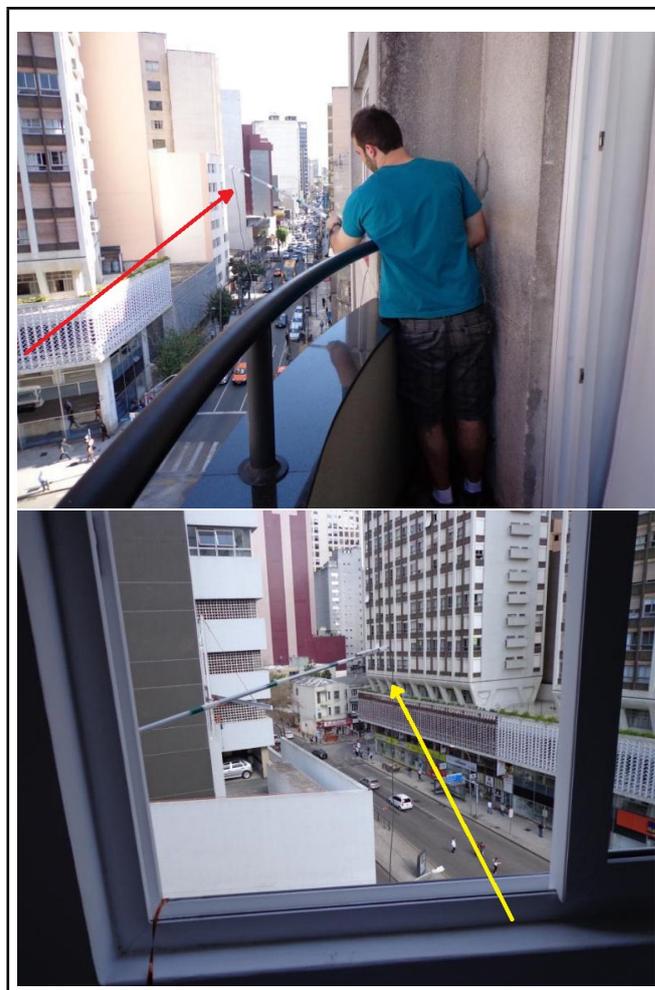
**Figure 8.** Use of a fishing rod to support the microphone during the measurements of facade 8 — external and internal views of the bedroom

Since Facade 8 was from a bedroom located on the 6<sup>th</sup> floor of an apartment building, the measurement of the  $L_{1,2m}$  level was taken with the external microphone attached to a fishing rod suspended on the balcony of an adjoining room. The procedure, illustrated in Fig. 8, allowed the microphone to be held 2 m away from the facade.<sup>14,20</sup>
